# Manhole Inspection Summary

Manhole # S29KK1022MH

Insp Date: **7/25/08 1:54 PM**

**Location** Address: **4220 WICKFORD RD**

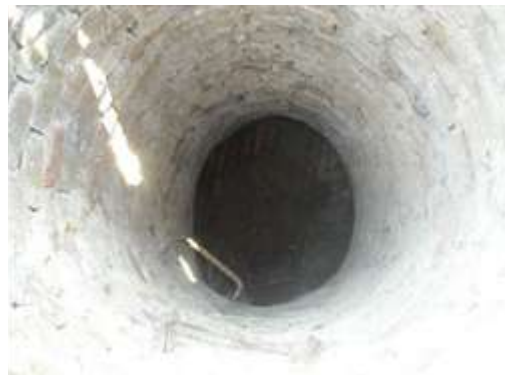
Top View

Corroded and missing steps. Channel debris.

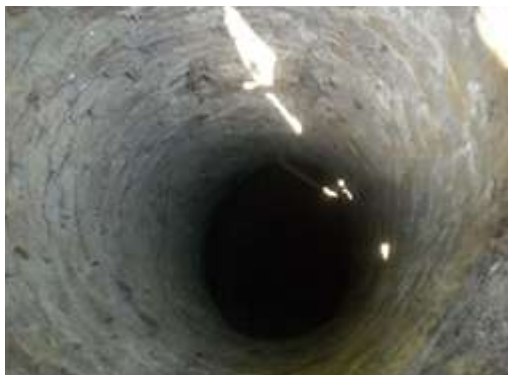
Defect

Corroded and missing steps. Corbel deterioration and infiltration. Barrel infiltration.

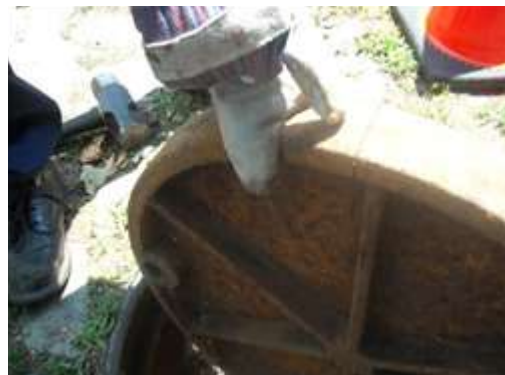
Defect

Cracked cover.

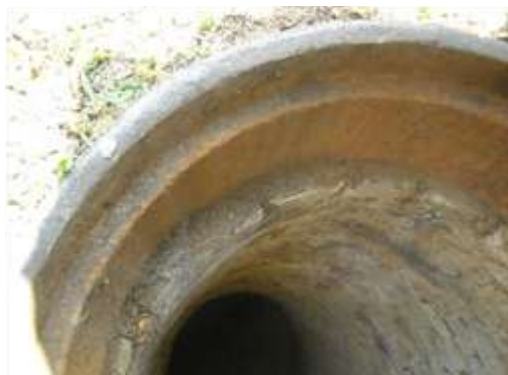
Defect

Frame offset. Corbel deterioration and infiltration. Barrel infiltration.

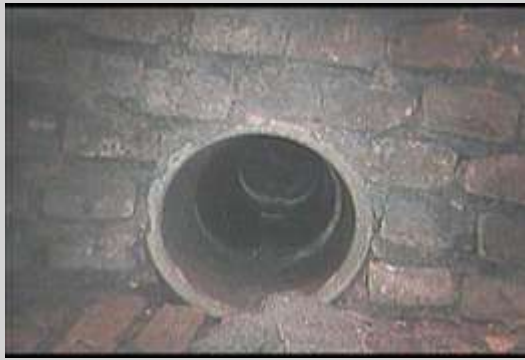
8 in. Circular Gravity Sewer  
Pipe Out @ 12 O'Clock

Infiltration: **None** Pipe Seal Cond: **Roots**
